OTTAWA COUNTY ENGINEERS OFFICE

REFERENCE NO. 13-6-15-G
 SW CORNER POST SEC. 13
 SALEM TWP.
 SHEET 1 OF 1.

ROUTE: T-217 MUDDY CREEK NORTH RD.

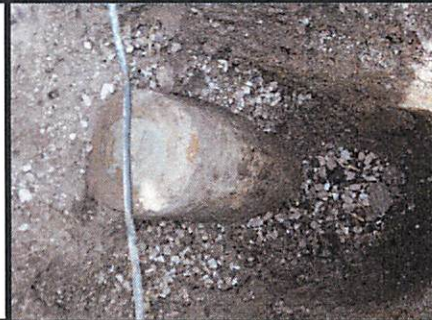
FD CONCRETE MONUMENT WITH BRASS DISK
 SEVERELY LEANING IN NORTHWESTERLY
 DIRECTION RESET IRON PIN.

FD PK NAIL AND SHINER ON SURFACE OVER A FD CONCRETE
 MONUMENT LEANING NORTHWESTERLY, SET BY D. GULAU PER
 1993 SURVEY. FD PK NAIL AND SHINER CHECKED CLOSELY WITH
 1939 WPA TIES FROM ESTABLISHMENT OF CONCRETE MONUMENT.
 DUG UP 6" Ø CONC MON AND VERIFIED IT IS DISTURBED AND
 LEANING. EXPOSED THE TOP 18" OF MONUMENT AND USED PROD
 TO FIND SE MOST EDGE OF BOTTOM OF MONUMENT. MEASURED
 3" IN LINE FROM FD SE EDGE NW TO CENTER OF TOP OF
 MONUMENT TO DETERMINE CENTER OF MONUMENT IF IT WERE
 UPRIGHT, A 5/8" Ø IRON PIN IN A MONUMENT BOX WAS SET AT
 THIS POINT AS SECTION CORNER.

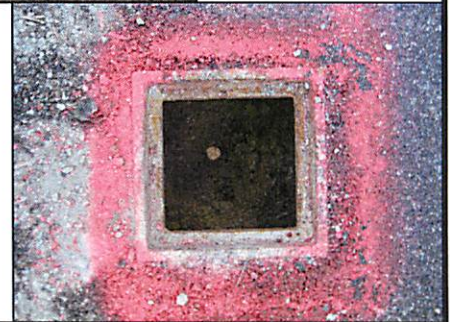
APRIL 21, 2014

SET 5/8" Ø IRON PIN IN
 MONUMENT BOX

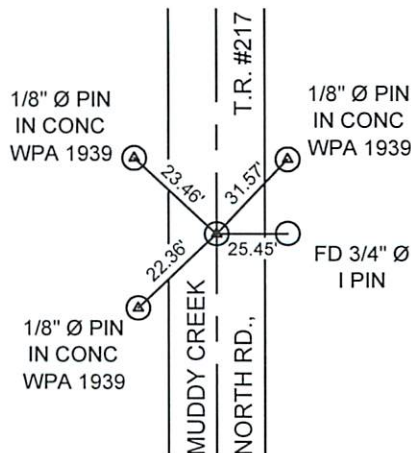
NW WPA 1939 WITNESS MONUMENT
 HAS BEEN DISTURBED. NE & SW WPA
 1939 WITNESS MONUMENT DISTANCES
 DID NOT INTERSECT WHICH MEANS
 ONE OR BOTH HAVE ALSO BEEN
 DISTURBED. ARCS FROM ALL THREE
 WITNESS MONUMENTS CREATED A
 TRIANGULAR GAP THEREFORE A POINT
 COULD NOT BE RESET BASED FROM
 TIES. THE SURFACE PK NAIL AND
 SHINER WAS LOCATED IN THE CENTER
 OF THE TRIANGULAR GAP.
