OTTAWA COUNTY ENGINEERS OFFICE

REFERENCE NO. 14-6-15-I
 SE CORNER POST SEC. 14
 SALEM TWP.
SHEET 1 OF 1.

ROUTE: T-217 MUDDY CREEK NORTH RD.

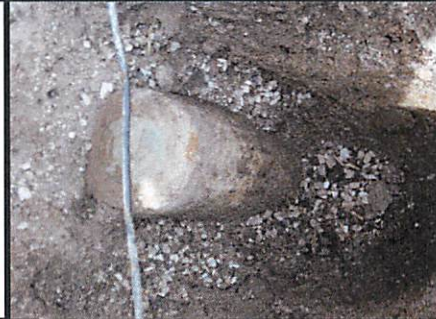
FD CONCRETE MONUMENT WITH BRASS DISK
 SEVERELY LEANING IN NORTHWESTERLY
 DIRECTION RESET IRON PIN.

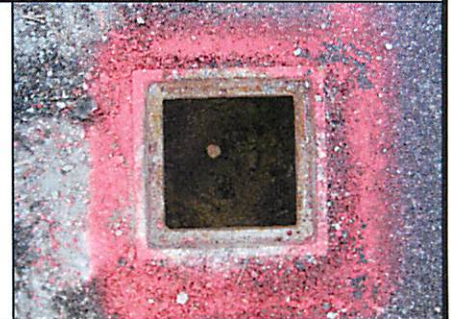
APRIL 21, 2014

SET 5/8" Ø IRON PIN IN
 MONUMENT BOX

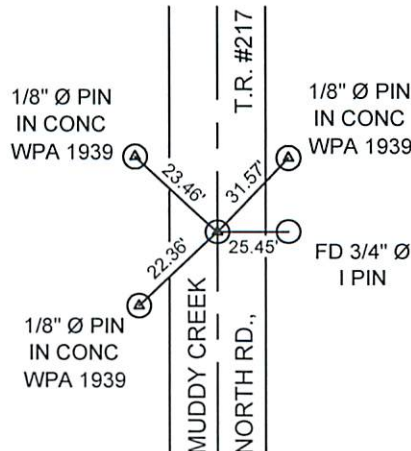
NOTE:
 NW WPA 1939 WITNESS MONUMENT
 HAS BEEN DISTURBED. NE & SW WPA
 1939 WITNESS MONUMENT DISTANCES
 DID NOT INTERSECT WHICH MEANS
 ONE OR BOTH HAVE ALSO BEEN
 DISTURBED. ARCS FROM ALL THREE
 WITNESS MONUMENTS CREATED A
 TRIANGULAR GAP THEREFORE A POINT
 COULD NOT BE RESET BASED FROM
 TIES. THE SURFACE PK NAIL AND
 SHINER WAS LOCATED IN THE CENTER
 OF THE TRIANGULAR GAP.
