OTTAWA COUNTY ENGINEERS OFFICE

REFERENCE NO. 23-6-15-C
 NE CORNER POST SEC. 23
 SALEM TWP.
SHEET 1 OF 1.

ROUTE: T-217 MUDDY CREEK NORTH RD.

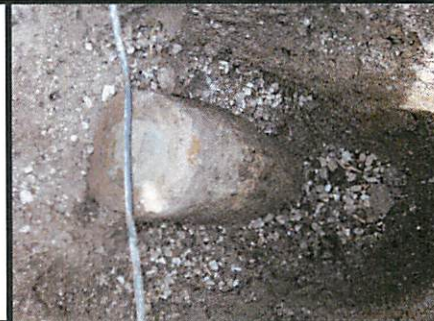
FD CONCRETE MONUMENT WITH BRASS DISK
 SEVERELY LEANING IN NORTHWESTERLY
 DIRECTION RESET IRON PIN.

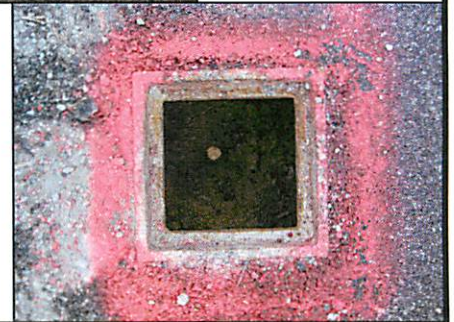
APRIL 21, 2014

FD PK NAIL AND SHINER ON SURFACE OVER A FD CONCRETE
 MONUMENT LEANING NORTHWESTERLY, SET BY D. GULAU PER
 1993 SURVEY. FD PK NAIL AND SHINER CHECKED CLOSELY WITH
 1939 WPA TIES FROM ESTABLISHMENT OF CONCRETE MONUMENT.
 DUG UP 6" Ø CONC MON AND VERIFIED IT IS DISTURBED AND
 LEANING. EXPOSED THE TOP 18" OF MONUMENT AND USED PROD
 TO FIND SE MOST EDGE OF BOTTOM OF MONUMENT. MEASURED
 3" IN LINE FROM FD SE EDGE NW TO CENTER OF TOP OF
 MONUMENT TO DETERMINE CENTER OF MONUMENT IF IT WERE
 UPRIGHT, A 5/8" Ø IRON PIN IN A MONUMENT BOX WAS SET AT
 THIS POINT AS SECTION CORNER.

SET 5/8" Ø IRON PIN IN
 MONUMENT BOX

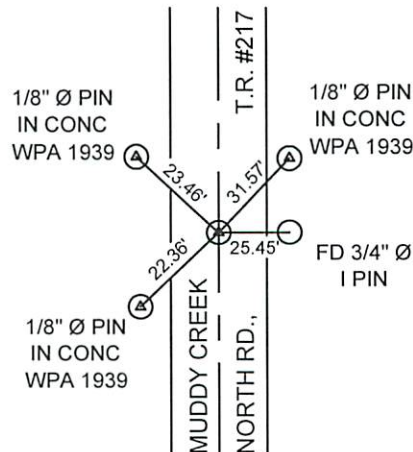
NOTE:
 NW WPA 1939 WITNESS MONUMENT
 HAS BEEN DISTURBED. NE & SW WPA
 1939 WITNESS MONUMENT DISTANCES
 DID NOT INTERSECT WHICH MEANS
 ONE OR BOTH HAVE ALSO BEEN
 DISTURBED. ARCS FROM ALL THREE
 WITNESS MONUMENTS CREATED A
 TRIANGULAR GAP THEREFORE A POINT
 COULD NOT BE RESET BASED FROM
 TIES. THE SURFACE PK NAIL AND
 SHINER WAS LOCATED IN THE CENTER
 OF THE TRIANGULAR GAP.
