# OTTAWA COUNTY ENGINEERS OFFICE

**REFERENCE NO.** 24-6-15-A  
 NW CORNER POST SEC. 24  
 SALEM TWP.  
**SHEET** 1 OF 1.

**ROUTE:** T-217 MUDDY CREEK NORTH RD.

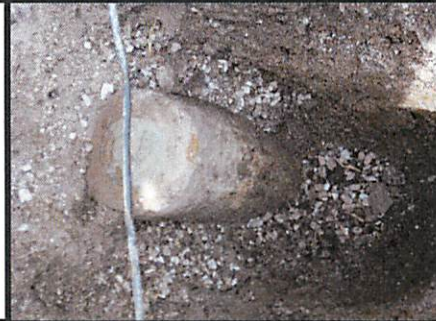
FD CONCRETE MONUMENT WITH BRASS DISK  
 SEVERELY LEANING IN NORTHWESTERLY  
 DIRECTION RESET IRON PIN.

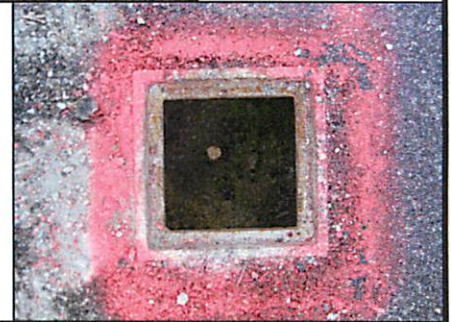
APRIL 21, 2014

SET 5/8" Ø IRON PIN IN  
 MONUMENT BOX

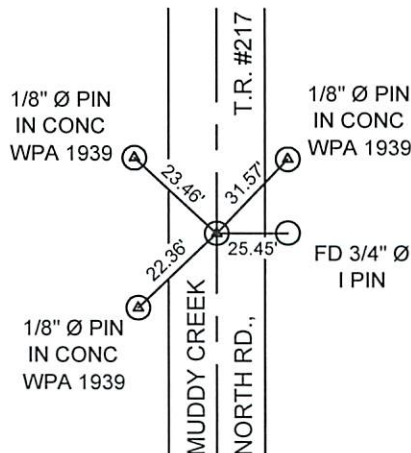
**NOTE:**  
 NW WPA 1939 WITNESS MONUMENT  
 HAS BEEN DISTURBED. NE & SW WPA  
 1939 WITNESS MONUMENT DISTANCES  
 DID NOT INTERSECT WHICH MEANS  
 ONE OR BOTH HAVE ALSO BEEN  
 DISTURBED. ARCS FROM ALL THREE  
 WITNESS MONUMENTS CREATED A  
 TRIANGULAR GAP THEREFORE A POINT  
 COULD NOT BE RESET BASED FROM  
 TIES. THE SURFACE PK NAIL AND  
 SHINER WAS LOCATED IN THE CENTER  
 OF THE TRIANGULAR GAP.
