OTTAWA COUNTY ENGINEERS OFFICE

REFERENCE NO. 13-6-15-G
 SW CORNER POST SEC. 13
 SALEM TWP.
 SHEET 1 OF 1.

ROUTE: T-217 MUDDY CREEK NORTH RD.

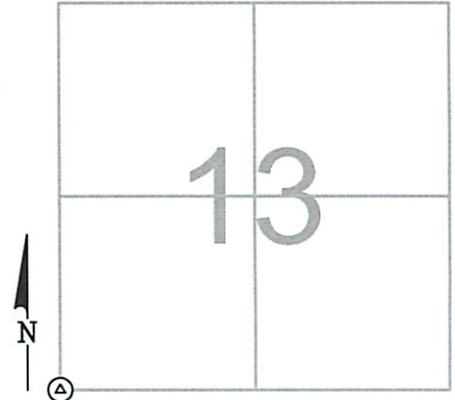
FD CONCRETE MONUMENT WITH BRASS DISK
 SEVERELY LEANING IN NORTHWESTERLY
 DIRECTION RESET IRON PIN.

FD PK NAIL AND SHINER ON SURFACE OVER A FD CONCRETE
 MONUMENT LEANING NORTHWESTERLY, SET BY D. GULAU PER
 1993 SURVEY. FD PK NAIL AND SHINER CHECKED CLOSELY WITH
 1939 WPA TIES FROM ESTABLISHMENT OF CONCRETE MONUMENT.
 DUG UP 6" Ø CONC MON AND VERIFIED IT IS DISTURBED AND
 LEANING. EXPOSED THE TOP 18" OF MONUMENT AND USED PROD
 TO FIND SE MOST EDGE OF BOTTOM OF MONUMENT. MEASURED
 3" IN LINE FROM FD SE EDGE NW TO CENTER OF TOP OF
 MONUMENT TO DETERMINE CENTER OF MONUMENT IF IT WERE
 UPRIGHT, A 5/8" Ø IRON PIN IN A MONUMENT BOX WAS SET AT
 THIS POINT AS SECTION CORNER.

MONUMENT TYPE: SET 5/8" Ø IRON PIN IN MON BOX
ON SURFACE - BELOW:
LEFT - CL PAV'T - RIGHT: 8.30'
