OTTAWA COUNTY ENGINEERS OFFICE

REFERENCE NO. 11-6-15-E
 CENTER POST SECTION 10
 SALEM TWP.
 SHEET 1 OF 1.

ROUTE: C-18 PORTAGE RIVER SOUTH RD.

MONUMENT INFORMATION

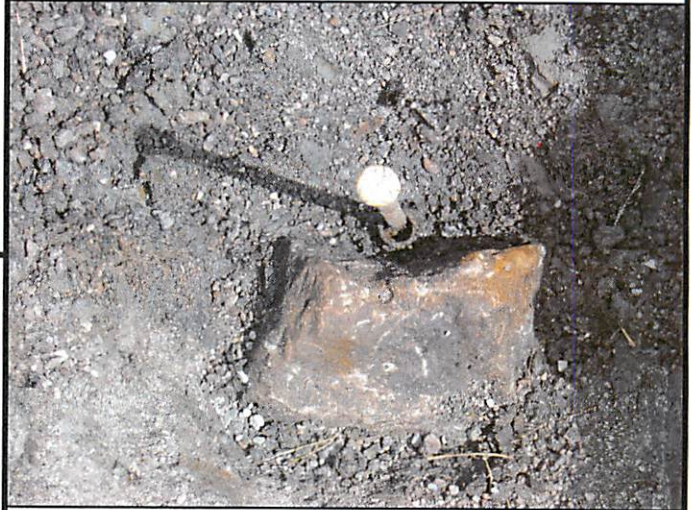
MONUMENT TYPE: FD STONE W/ DRILL HOLE
 ON SURFACE - BELOW: 1.21'
 LEFT - CL PAV'T - RIGHT: 10.09'

RECTANGULAR STONE: 6" x 10"

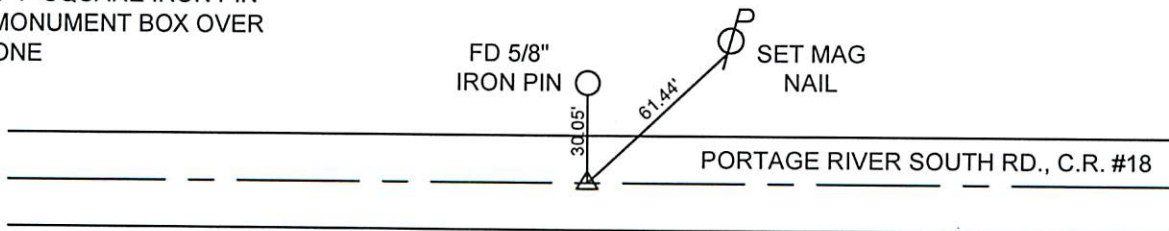
FD UNREADABLE CAPPED 1/2" IRON PIN IN BERM,
 2.0' S. OF C/L OF S. WHITE PAVEMENT LINE, TIED
 PIN W/SHORT TIES. DUG TO STONE. PIN WAS IN
 PIPE ON NORTH SIDE OF STONE. PIN DID NOT
 FIT DRILL HOLE IN STONE. DROVE PIN FUTHER
 DOWN AND SET NEW PIN OVER DRILL HOLE.

SET 1" SQUARE IRON PIN
 IN MONUMENT BOX OVER
 STONE

SHORT PK TIES
 PK NW - 11.05'
 PK N - 5.10'
 PK NE - 8.38'
